# COMPLETE ROOF REPAIR

KENTRA  
APARTMENT  
SPECIALISTS LTD.

## THE ROOF LEAKS

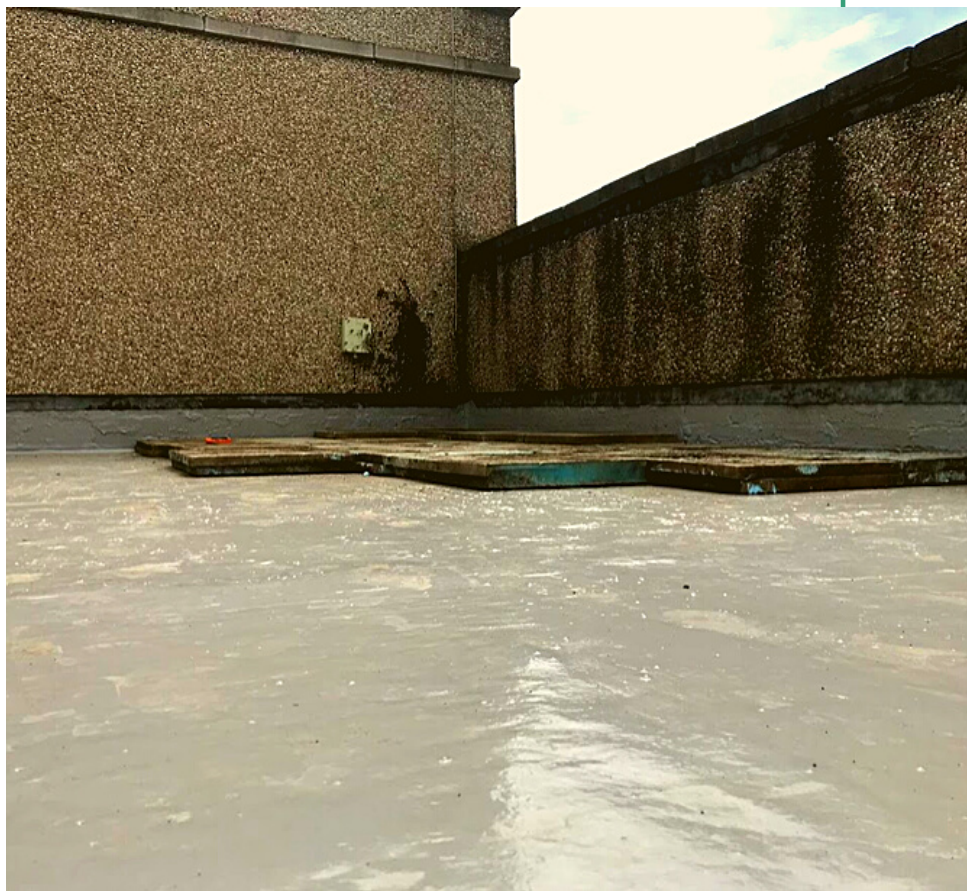
The aim of this project was to provide a solution to the flat roof of an apartment block that had an extensive history of leaks which had been rectified with temporary, short-term solutions. The building is approx. 25 years old and had a roof garden installed when it was constructed. This garden had fallen into disrepair over time, the planters had become overgrown and the roots penetrated the felt in numerous places causing water ingress in private apartments and common areas.

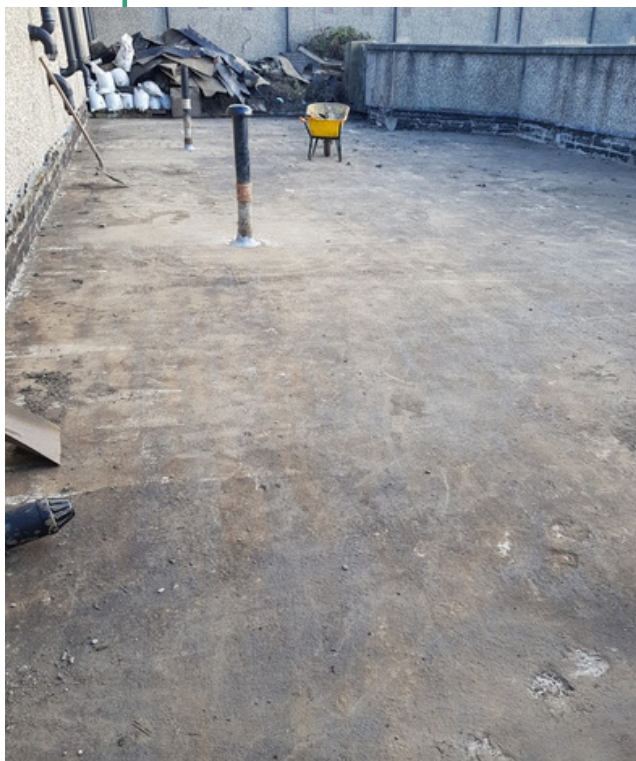
## THE WORK STEP 1 - CLEARING

The decision was made to repair the roof felt with more modern system. Before work could commence on repairing the roof, all aspects of the roof garden had to be removed. This meant cutting down all of the overgrown trees and removing all of the planters and the soil. The paving stones and insulation boards were stored on site allowing us to remove and dispose of the damaged felt.

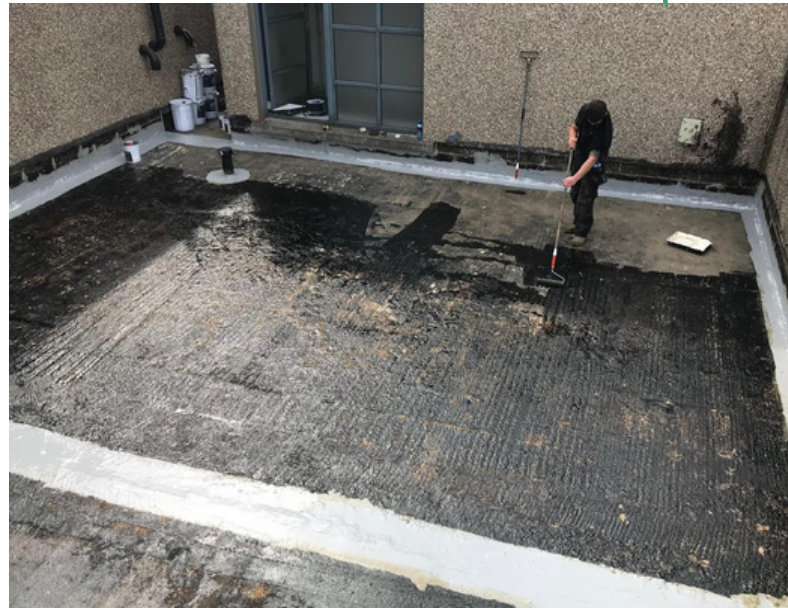
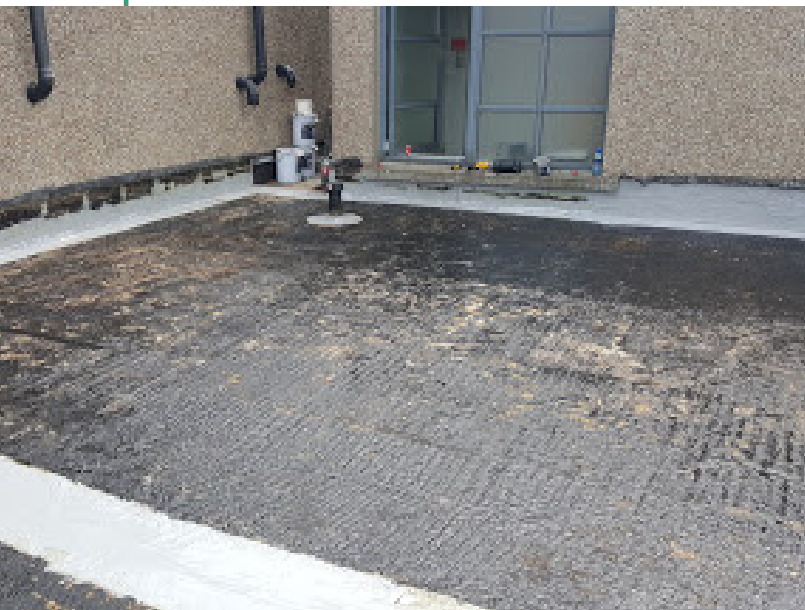
### STEP 2 - PREPARING

With a clear roof, our team was able to begin the process of installing the new roof system - Lava 20 - a single component, polyurethane, liquid, waterproof membrane.

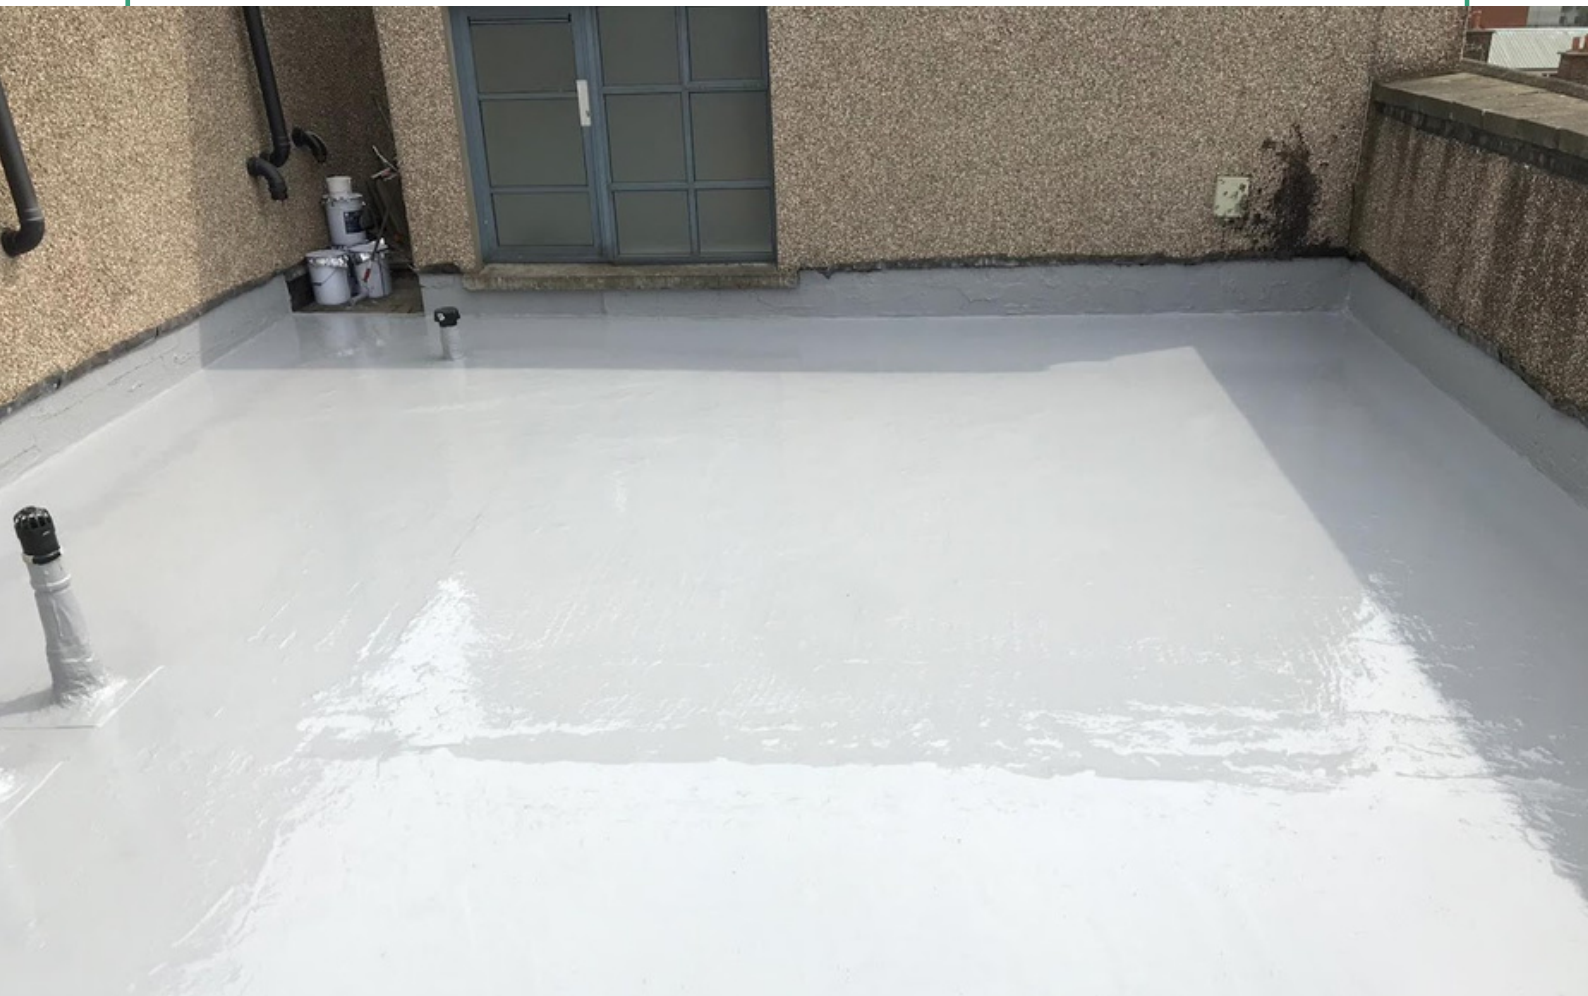
### STEP 3 - LAVA 20

Lava 20 was applied onto the roof. This is a single component polyurethane waterproofing system with a manufacturer 25 year guarantee

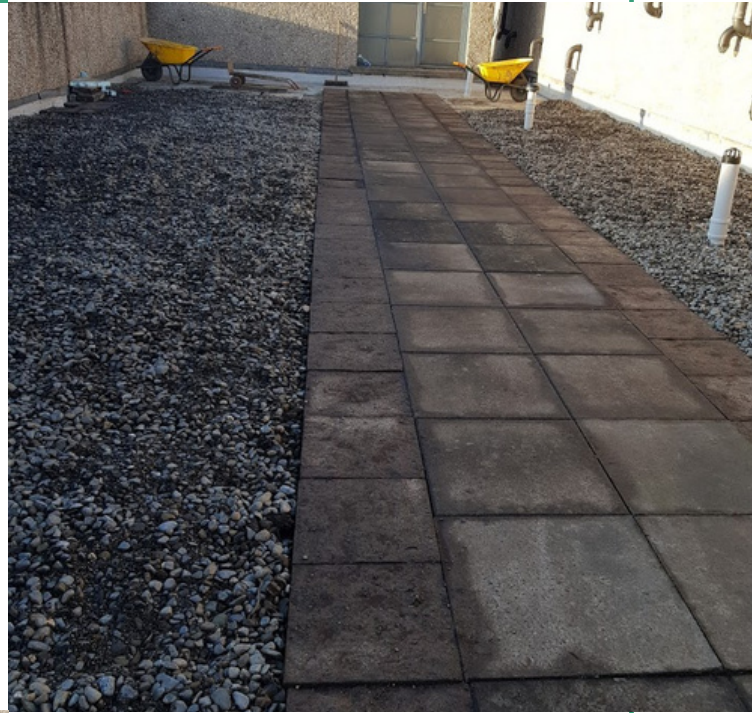
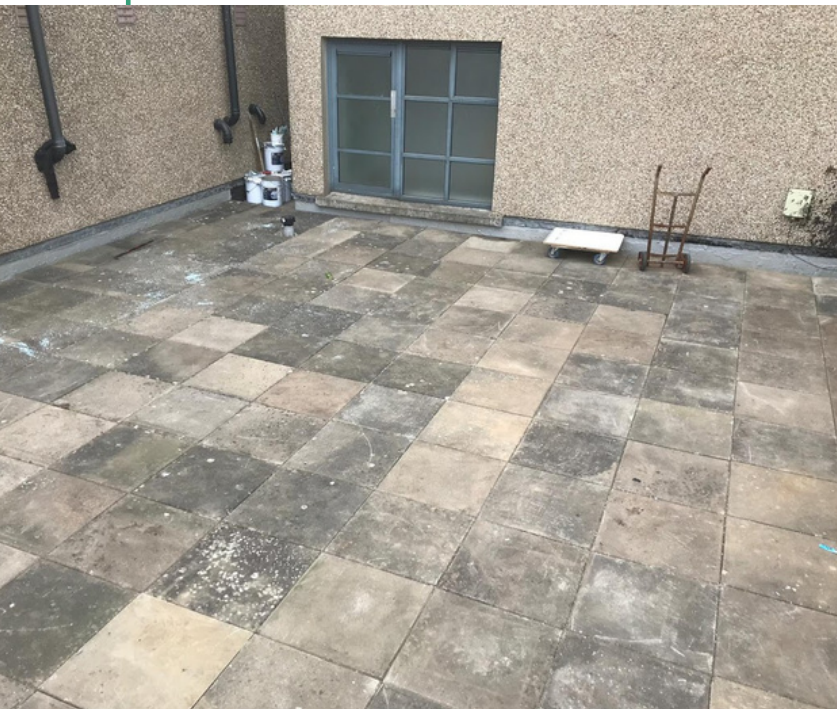
### STEP 4 - REINSTATE INSULATION & PAVERS

The insulation and paving stones were reinstated with the addition of some decorative stone.
